7th Street Peninsula Environmental Concerns

Flood Hazards

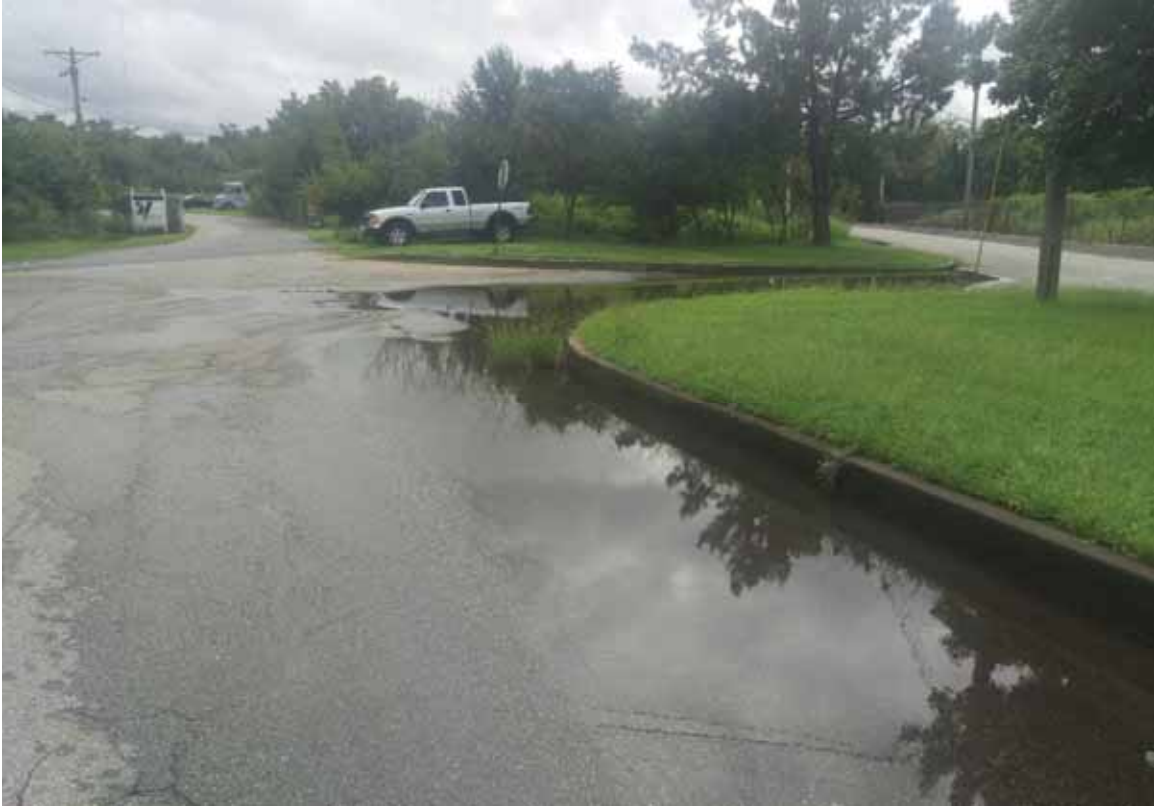
The public reported that there are several locations where flooding regularly occurs along the Peninsula owing to rainfall events or occasional high tides (spring tides). Century performed field visits on August 21st and 22nd to evaluate the Peninsula following an approximately 0.30-inch rain event. Flooding was observed in many of the low-lying areas along roadways and in the shallow swales between entrances on Industrial Avenue. Flooding up to 4-inches in depth was observed at the intersection of East 7th Street and Industrial Avenue. No other roadways appeared impacted.

The flooding observed appears due to underperforming and unmaintained drainage infrastructure. Site visits also revealed that there is poor grading on the Peninsula and its roadways. The primary road to and through the Peninsula is East 7th Street, which has a low point at its intersection with Industrial Avenue. During two field visits to the site, Century observed that the entire intersection of East 7th Street and Industrial Avenue was inundated by flood water as shown in the picture in Figure 1. Also visible in this photograph are grasses growing up through a catch basin located in the foreground, which indicates that the storm drain pipe is likely clogged with sediment. The underperformance of the drainage system, based on this preliminary investigation, is likely caused by debris/sediment clogging the drainage pipes. Evidence suggesting that the drainage system is severely clogged include the grasses growing through a catch basin and the fact that the ponding remained constant over the course of two days. It is noted that there was no evidence that the inundation limits at this location were tidally influenced (as would be indicated by debris or water stains on the pavement).

Figure 1: A photograph of the submerged intersection of 7th Street and Industrial Ave.

Maintenance of the existing drainage system, as well as improvements to the connectivity of the drainage system will reduce nuisance flooding and mitigate impacts from smaller storm events. The installation of a tide gate or “flapper valve” will be required to prevent tidal backflow through the drainage system. The entire existing drainage system should be surveyed to evaluate the system for capacity and potential improvements.

Currently the lowest point on the Peninsula is the intersection of East 7th Street and Industrial Avenue. Consideration should be given to identifying areas for stormwater storage, most likely in the form of a wet pond. A stormwater management facility, such as a wet pond, will allow stormwater runoff to be temporarily stored at a less impactful location during high tides, then drained out through the drainage network during low tides.

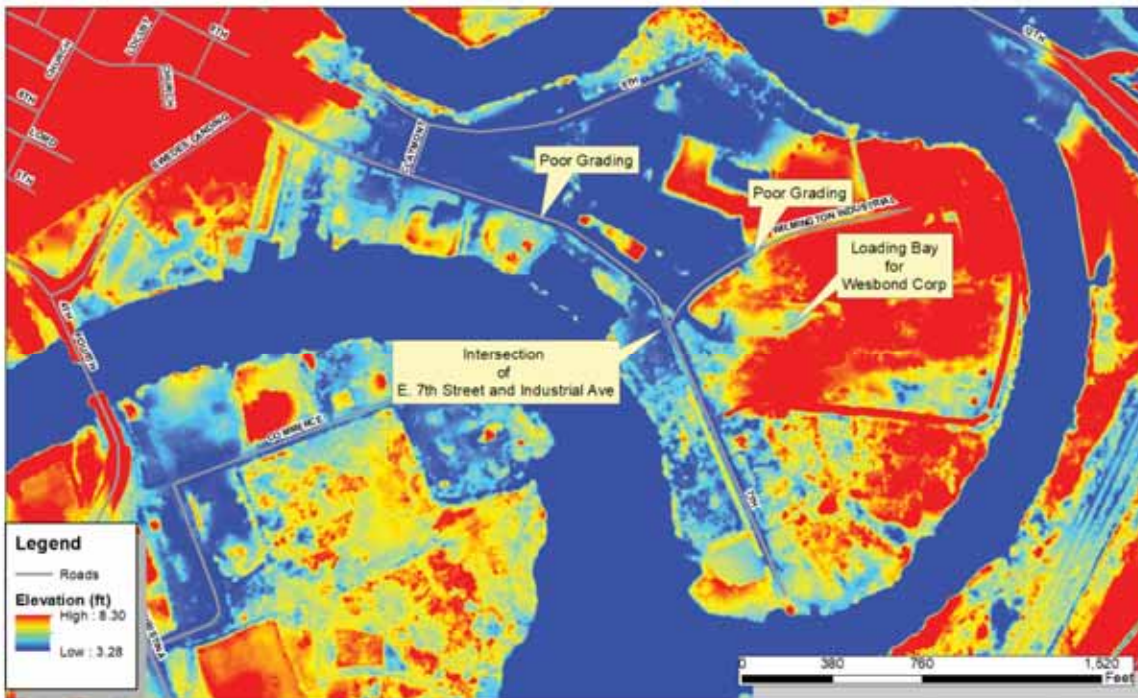
In addition to the flooding along East 7th Street, the Peninsula is poorly graded for drainage. The property at 1135 E. 7th Street (Wesbond Corp) is a developed parcel which is at the lowest elevation along the Peninsula. During the site visit, Century spoke with an employee for Wesbond Corp who was pumping storm water near the loading bay for their facility. This employee mentioned that other property owners have elevated their buildings by constructing building pads on fill, which has exacerbated flooding at Wesbond Corp. These buildings have done so to maintain a finished floor elevation above the Base Flood Elevation (BFE). Figure 2 shows a map displaying the ground elevations along the Peninsula. The upper

limit of the color scale representing the ground elevations (red) is 8.30' NAVD88, which is the 100 - Year flood elevation. The red rectangular shapes indicate where buildings have most likely been elevated to achieve finished floor elevations exceeding the BFE.

Figure 2: Elevations on the Peninsula

Figure 2 indicates several areas where building sites have been elevated, creating low areas between the sites where drainage has not been accommodated. Additionally, as the building pads have been raised, the road elevations have not, resulting in the roadways becoming a primary conduit for runoff during heavy rainfall events.

As aforementioned, on an individual basis, property owners have filled individual sites to establish their buildings first finished floor above the BFE. Since each of these sites do not manage their storm water runoff this filling has likely exacerbating the underperformance of the drainage system. Therefore, developing a comprehensive development and drainage plan for the entire Peninsula is a fundamental design element in avoiding nuisance flooding from poor drainage and reducing future flood probabilities. A potential solution to nuisance flooding and a mitigating factor in extreme flooding scenarios would be

elevate the remaining building pads as well as East 7th Street and Industrial Ave to match the elevations of the raised building sites.

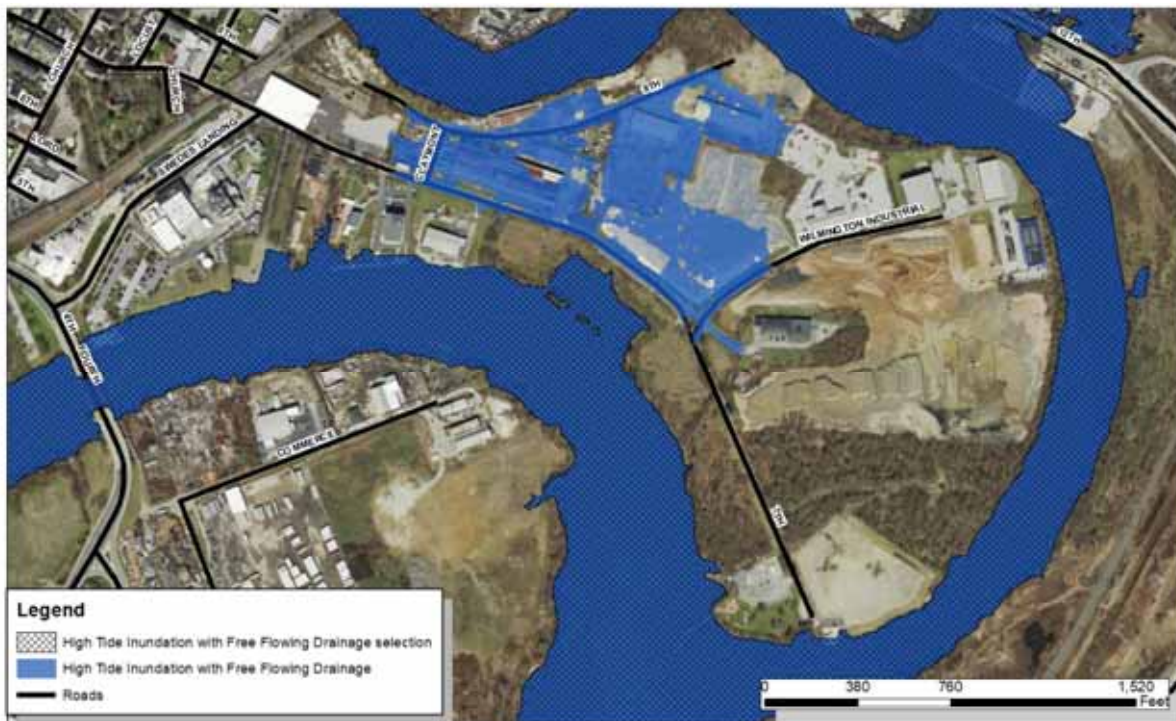
During the field visit, Century Engineering identified high water marks along shore protection or coastal armoring structures, as well as, searched for high water inundation debris lines. Century witnessed high water and debris lines along rip rap features and in vegetated areas. Century approximated the high-water elevation to be roughly 3.41' NAVD88 derived from the CoNED Topobathymetric Model for the New Jersey and Delaware, 1880 to 2014 LiDAR elevation dataset. This elevation approximately matched the indicators of the daily high tides. Figure 3, below, shows the limits of flooding due to regular tide cycles. It is noted that the catch basin at the lowest elevation along E. 7th Street is at 1.93' NAVD88. Therefore, it is possible that tidal flooding may result in backwater flooding through the drainage network, inundating the interior of the Peninsula as show in light blue in Figure 3. This action currently does not appear to occur due to the clogged drainage network. It is also notable that during regular tide events the northwest edge of the Peninsula, which has a depressed area along the Brandywine River, nearly overtops. If this location overtops, the interior of the Peninsula will fill with tidal waters, much like a bath tub. While this does not appear to occur during regular tie cycles, it likely does occur during monthly high tide cycles or during rain events coinciding with high tides.

Figure 3: Tidal Flooding along the 7th Street Peninsula

Considering this, it is Century's opinion that nuisance flooding is primarily due to a lack of drainage and stormwater management infrastructure, poorly maintained drainage infrastructure, and lack of a comprehensive drainage plan for the Peninsula.

The Peninsula is currently shaped like a bathtub, with portions of the center of the Peninsula being lower in elevation than the perimeter. There is an area along the northwest side of the perimeter that is lower in elevation than the remainder. This low area should be elevated through either fill or bulkheading to increase the perimeter elevation and reduce the frequency of overtopping and subsequent tidal flooding.

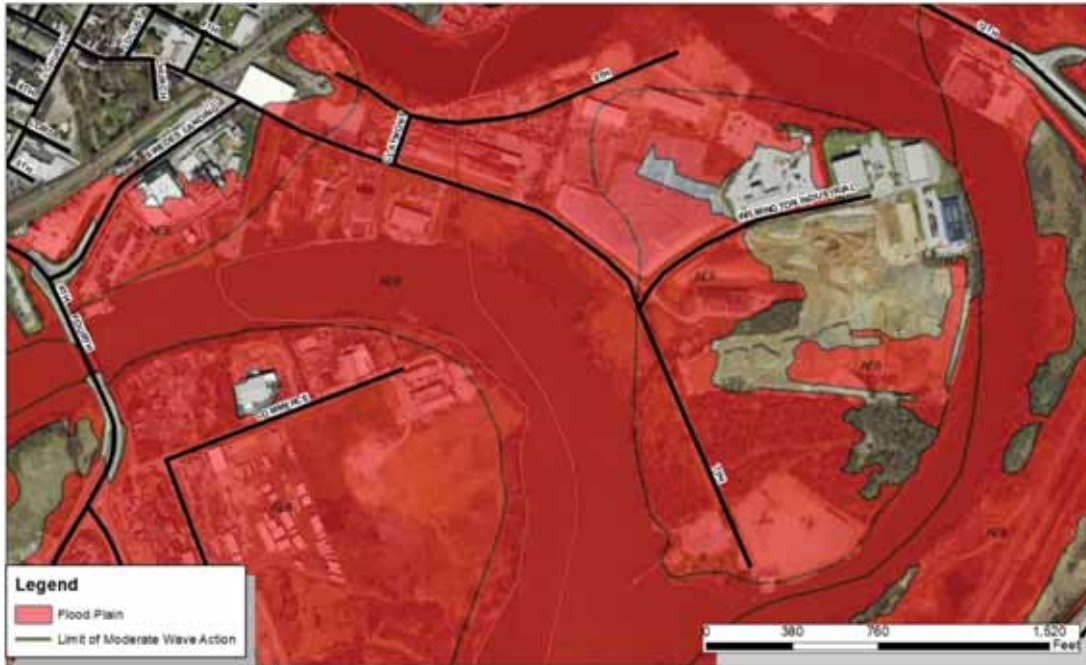
The effective Digital Flood Insurance Rate Map (DFIRM) is the most technically sound basis from which to infer flood hazards surrounding the Peninsula. The DFIRM (4) shows nearly the entire Peninsula being submerged under water during the 1-percent-annual-chance (100 Year) flood event.

Figure 4: DFIRM for 7th Street Peninsula

Also demonstrated in the DFIRM is the fact that a portion of the Peninsula is impacted by ‘moderate’ wave energy – which are waves greater than 1.5’, but less than 3’, in height. During the production of the DFIRM, the potential wave energy along the Peninsula was interpolated between two (2) modeling transects, which originate along the Delaware River/Bay. Century also performed a local fetch analysis along the Peninsula to verify that, in fact, the Peninsula may be vulnerable to such wave energy. From this fetch analysis, wave heights as great as from 1.72’ to 2.65’ may be experienced along the Christina River coastline of the Peninsula. The results of the locally generated wave analysis are shown in Table 1, where the wave heights at the Skate Park and Kalmar Nyckel are based on 2,290’ and 3,573’ of fetch, respectively. During a visit to the site, Century confirmed with a local observer of flood and erosion conditions at Kalmar Nyckel who stated that waves of roughly 2-3’ are observed with strong winds blowing from the east-southeast direction.

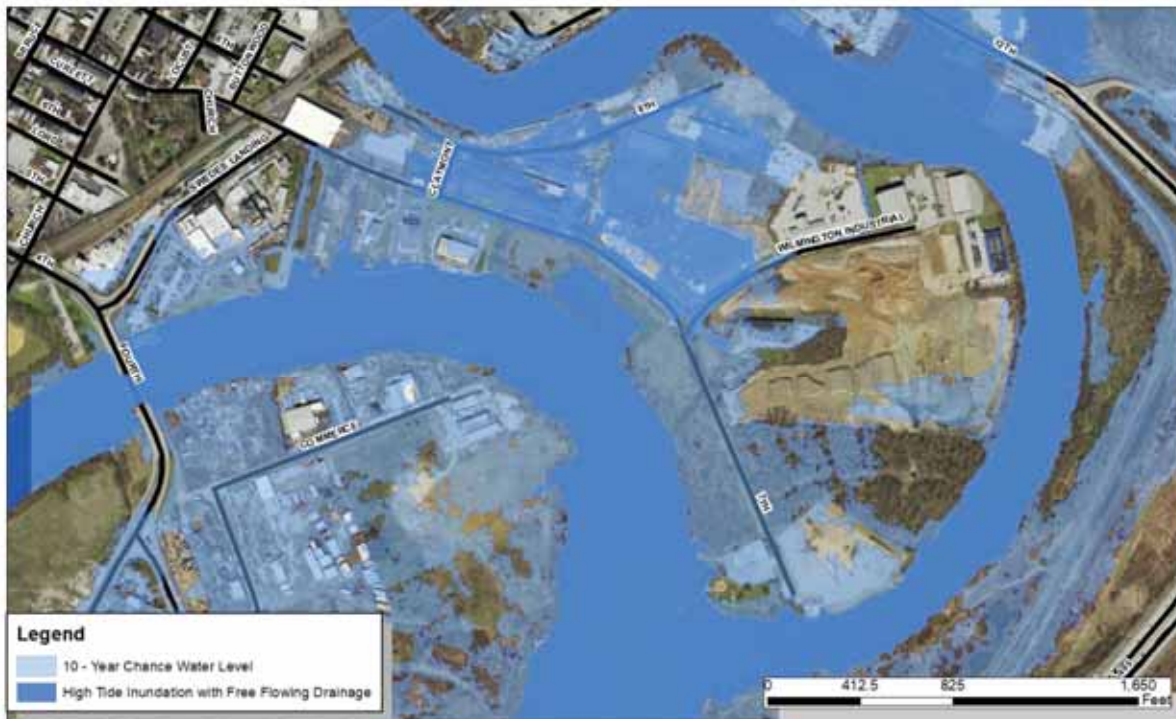
The table also provides the percent chance that each of these water levels may be experienced at least one time during a period of 25 and 50 years. As can be seen in Table 2, it is almost certain that the 10 – Year water level will be experienced over the course of any expected period of engineering design. The flood depths resulting from this water level is shown in Figure 5.

Figure 5: Inundation Extent of the 10-Year Water Level
