**SR 48 AT HEDGEROW PLACE/HARLECH DRIVE AND SR 48 AT COURTNEY ROAD
TRAFFIC SIGNAL WARRANT EVALUATION
JANUARY 30, 2019**

The following study presents the signal warrant analysis at SR 48 and Hedgerow Place/Harlech Drive and at SR 48 and Courtney Road.

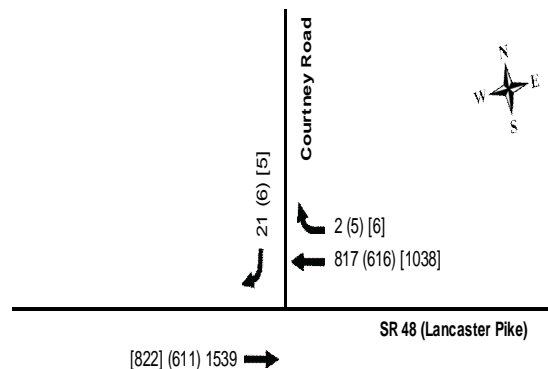
FIGURE 3
Peak Hour Volumes

Turning movement counts were conducted on Wednesday, April 25, 2018 from 6:00 AM to 7:00 PM at the intersection of SR 48 and Courtney Road and are summarized in Figure 3.

00: AM Peak Hour (7:15 - 8:15 AM)

(00): Midday Peak Hour (1:00 - 2:00 PM)

[00]: PM Peak Hour (4:30 - 5:30 PM)

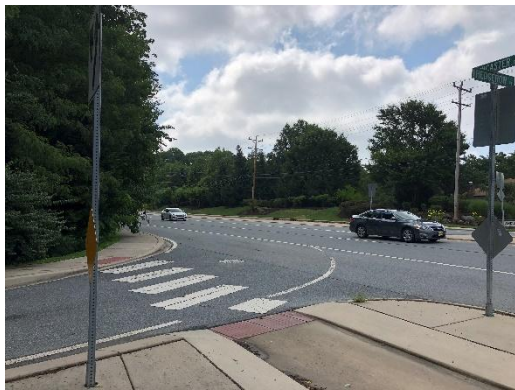
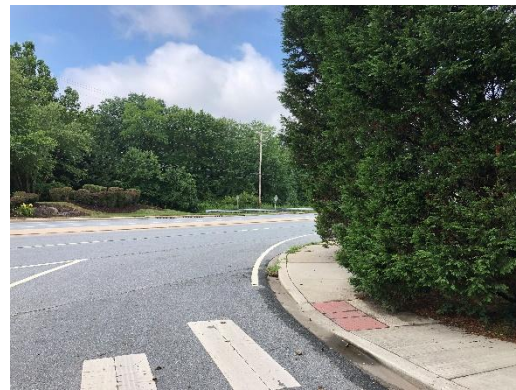
As shown in Table 1, the southbound Hedgerow Place corner sight distances looking left and right at SR 48 do not meet AASHTO criteria when vehicles are positioned at the stop line (view is obstructed by trees to the left and to the right; see Photos 1-2). Southbound Hedgerow Place corner sight distances looking left and right meet AASHTO criteria when vehicles move beyond the stop line (see Photos 3-4). During field observations, it was noted that many vehicles pull forward and wait beyond the stop line before turning onto SR 48.

Photo 1: Southbound Hedgerow Place corner sight distance looking left onto SR 48 (from stop line)

Photo 2: Southbound Hedgerow Place corner sight distance looking right onto SR 48 (from stop line)

At this time, no changes to the intersection operations or geometrics at SR 48 at Hedgerow Place/Harlech Drive and at SR 48 at Courtney Road are recommended. With eight reported crashes in the more than five-year study period at the two intersections, only one of which was a type potentially correctable by signalization, there are no significant safety concerns at these locations. The current channelized design of the intersection and the restricted side-street left-turns reduces the potential conflict points thus creating a safer intersection with less chances of a crash occurring. Additionally, no signal warrants are met; therefore, no signalization is recommended at this time. However, it is recommended to trim the trees within the right-of-way on the corners of SR 48 at the intersections of Hedgerow Place and Courtney Road.

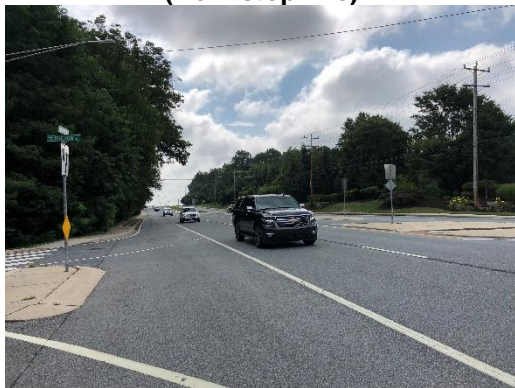
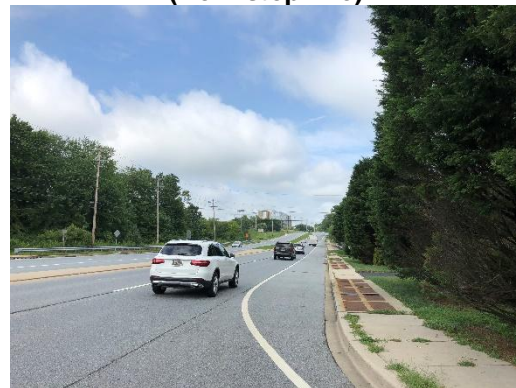
Photo 3: Southbound Hedgerow Place corner sight distance looking left onto SR 48 (beyond stop line)

Photo 4: Southbound Hedgerow Place corner sight distance looking right onto SR 48 (beyond stop line)

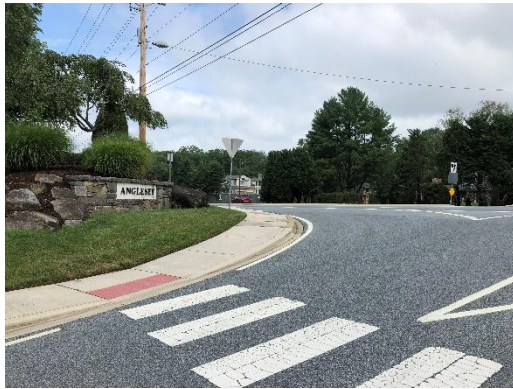
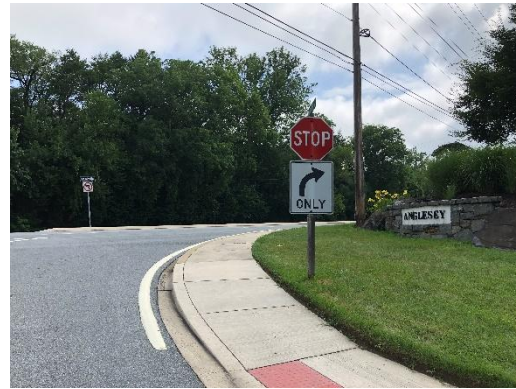
As shown in Table 2, the northbound Harlech Drive corner sight distances looking left and right at SR 48 do not meet AASHTO criteria when vehicles are positioned at the stop line (view is obstructed by slope and landscaping to the left and to the right; see Photos 5-6). Northbound Harlech Drive corner sight distances looking left and right meet AASHTO criteria when vehicles move beyond the stop line (see Photos 7-8). During field observations, it was noted that many vehicles pull forward and wait beyond the stop line before turning onto SR 48.

Photo 5: Northbound Harlech Drive corner sight distance looking left onto SR 48 (from stop line)

Photo 6: Northbound Harlech Drive corner sight distance looking right onto SR 48 (from stop line)

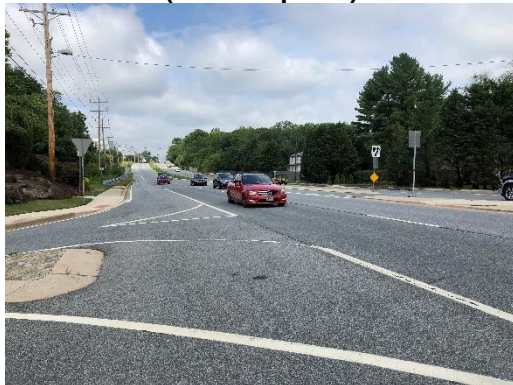
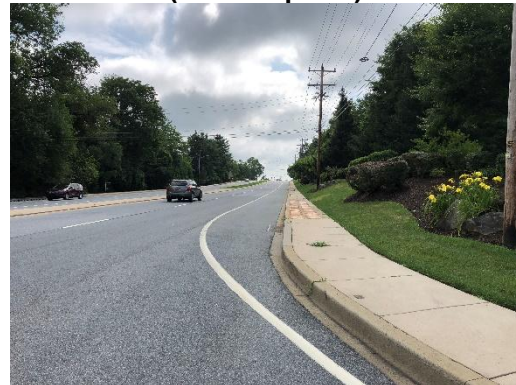
Photo 7: Northbound Harlech Drive corner sight distance looking left onto SR 48 (beyond stop line)

Photo 8: Northbound Harlech Drive corner sight distance looking right onto SR 48 (beyond stop line)

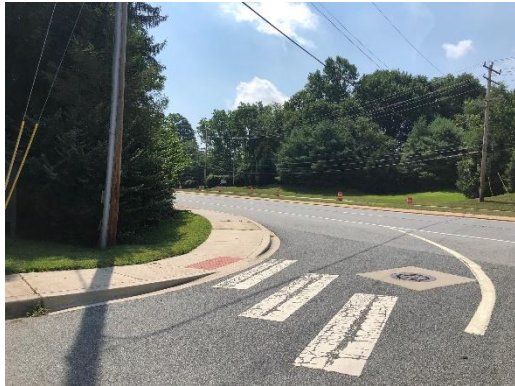
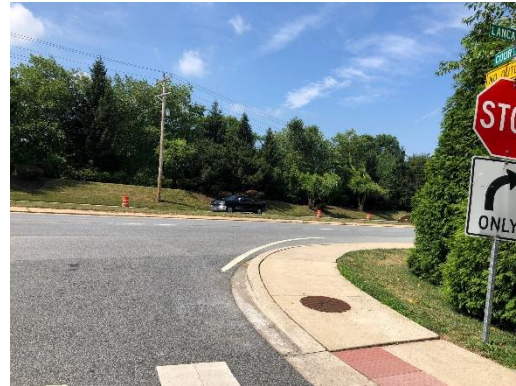
As shown in Table 3, the southbound Courtney Road corner sight distances looking left and right at SR 48 do not meet AASHTO criteria when vehicles are positioned at the stop line (view is obstructed by trees to the left and to the right; see Photos 9-10). Southbound Courtney Road corner sight distance looking left does not meet AASHTO criteria when vehicles move beyond the stop line due to the crest vertical curve on westbound SR 48 (see Photo 11). The measured intersection sight distance is 275 feet, 45 feet less than the calculated minimum AASHTO intersection sight distance guideline of 320 feet. Southbound Courtney Road corner sight distance looking right meets AASHTO criteria when vehicles move beyond the stop line (see Photo 12). During field observations, it was noted that many vehicles pull forward and wait beyond the stop line before turning onto SR 48.

Photo 9: Southbound Courtney Road corner sight distance looking left onto SR 48 (from stop line)

Photo 10: Southbound Courtney Road corner sight distance looking right onto SR 48 (from stop line)

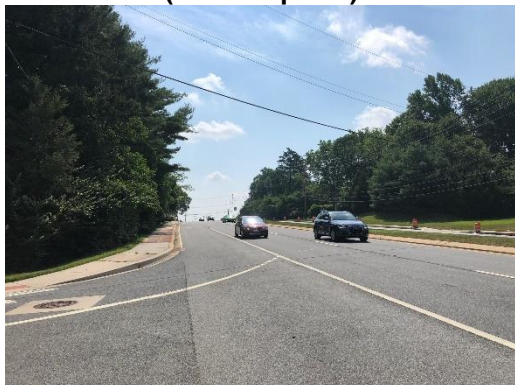
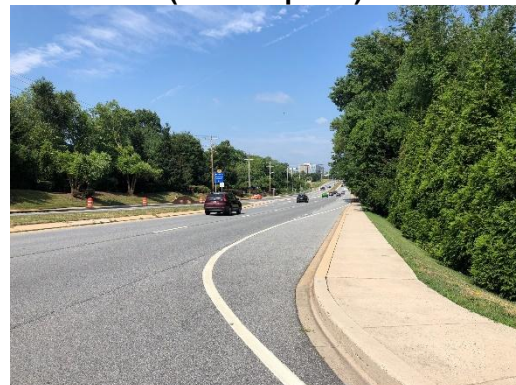
Photo 11: Southbound Courtney Road corner sight distance looking left onto SR 48 (beyond stop line)

Photo 12: Southbound Courtney Road corner sight distance looking right onto SR 48 (beyond stop line)
