**SR 48 AT HICKORY SPRING ROAD (“OLD HOBSON FARM”)
TRAFFIC SIGNAL WARRANT EVALUATION
JANUARY 30, 2019**

The following study presents the signal warrant analysis at SR 48 (Lancaster Pike) and Hickory Spring Road (a.k.a. “Old Hobson Farm”).

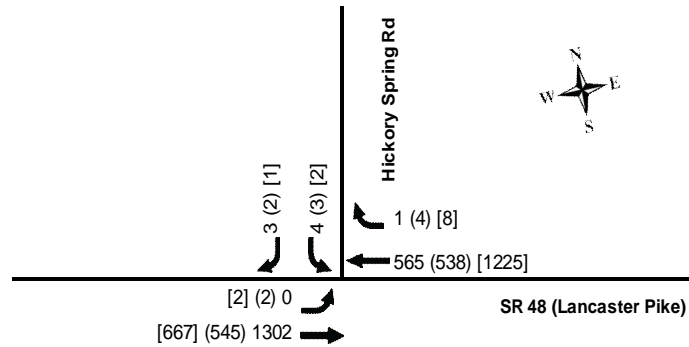
**FIGURE 2
Peak Hour Volumes**

Turning movement counts were conducted on Tuesday, May 8, 2018 from 6 AM to 7 PM and are depicted in Figure 2.

May 8, 2018 Traffic Volumes
 00: AM Peak Hour (7:15 - 8:15 AM)
 (00): Midday Peak Hour (1:00 - 2:00 PM)
 [00]: PM Peak Hour (4:30 - 5:30 PM)

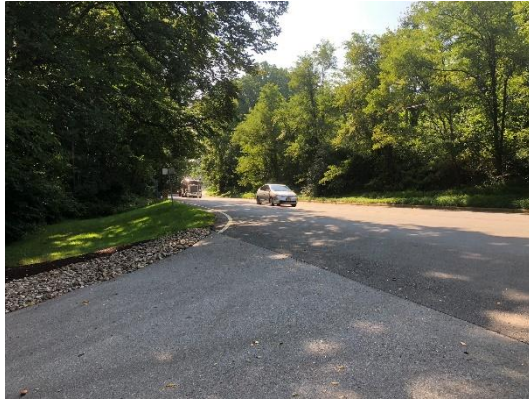
Photo 1: Southbound Hickory Spring Rd corner sight distance looking left onto SR 48 (from "stop line")

As shown in Table 1, the southbound Hickory Spring Road corner sight distances looking left and right at SR 48 do not meet AASHTO criteria when vehicles are positioned 10 feet from the edge of the roadway (see Photos 1-2). Southbound Hickory Spring Road corner sight distances looking left meet AASHTO criteria when vehicles move forward to about 5 feet from the edge of roadway, but the corner sight distance is still not met looking right (see Photos 3-4). The stopping sight distances for eastbound and westbound SR 48 exceed AASHTO criteria.

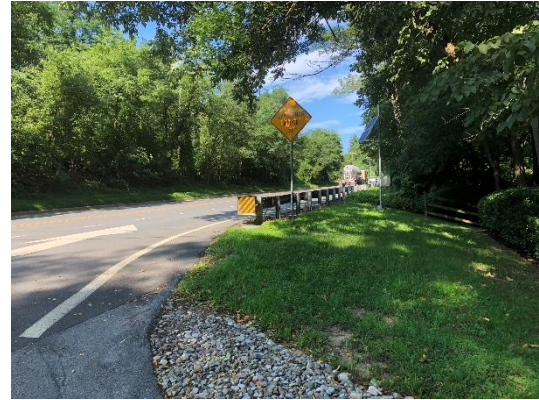
Photo 2: Southbound Hickory Spring Rd corner sight distance looking right onto SR 48 (from "stop line")

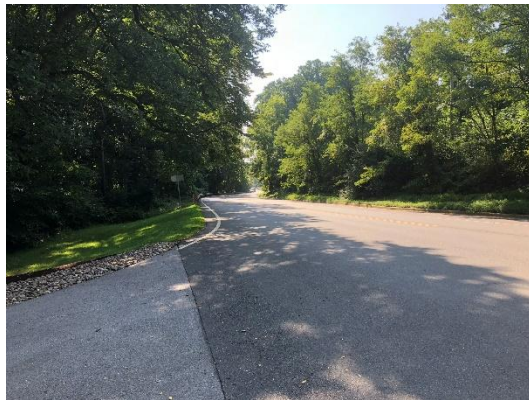
Photo 3: Southbound Hickory Spring Rd corner sight distance looking left onto SR 48 (beyond "stop line")

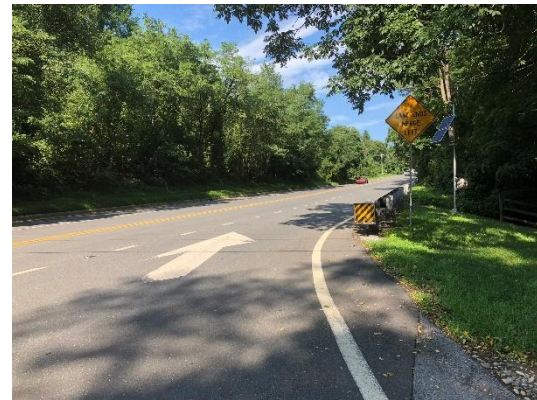
Photo 4: Southbound Hickory Spring Rd corner sight distance looking right onto SR 48 (beyond "stop line")
