MEMORANDUM

Date: April 22, 2019
To: Mark Luszcz, P.E., PTOE, Chief Traffic Engineer, DeIDOT
From: B.J. Song, RK&K
Jim Burnett, RK&K
CC: Peter Haag, DeIDOT
Subject: **Cooke Elementary School – School Zone Speed Review**

**SR 7, SR 41 and SR 48 Transportation Improvements
School Speed Limit Study
Cooke Elementary School**

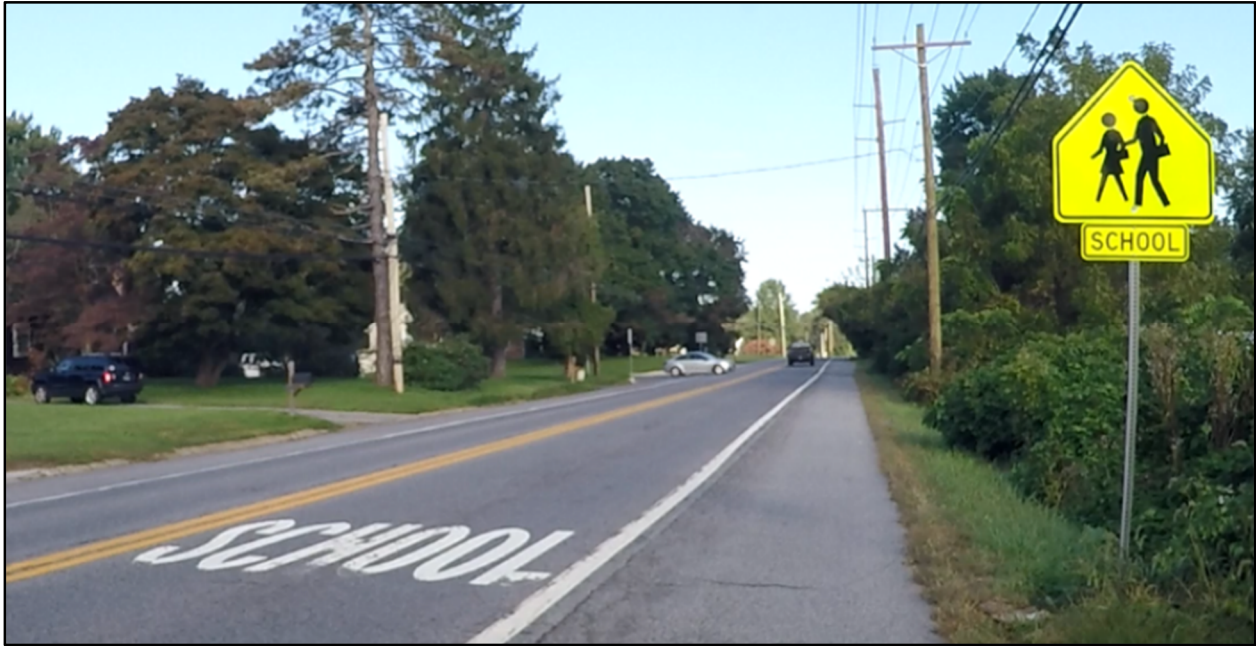
Picture 1: A Vehicle Making a Left-turn from the School Bus Only Access to Northbound SR 41

- The School Bus-Only access on SR 41 is designed to accommodate both left-turns and right-turns into the school from SR 41, but only right turns out of the school onto southbound SR 41; however, a few automobiles were observed making a left-turn from the School Bus Access on to northbound SR 41 (see Picture 1).

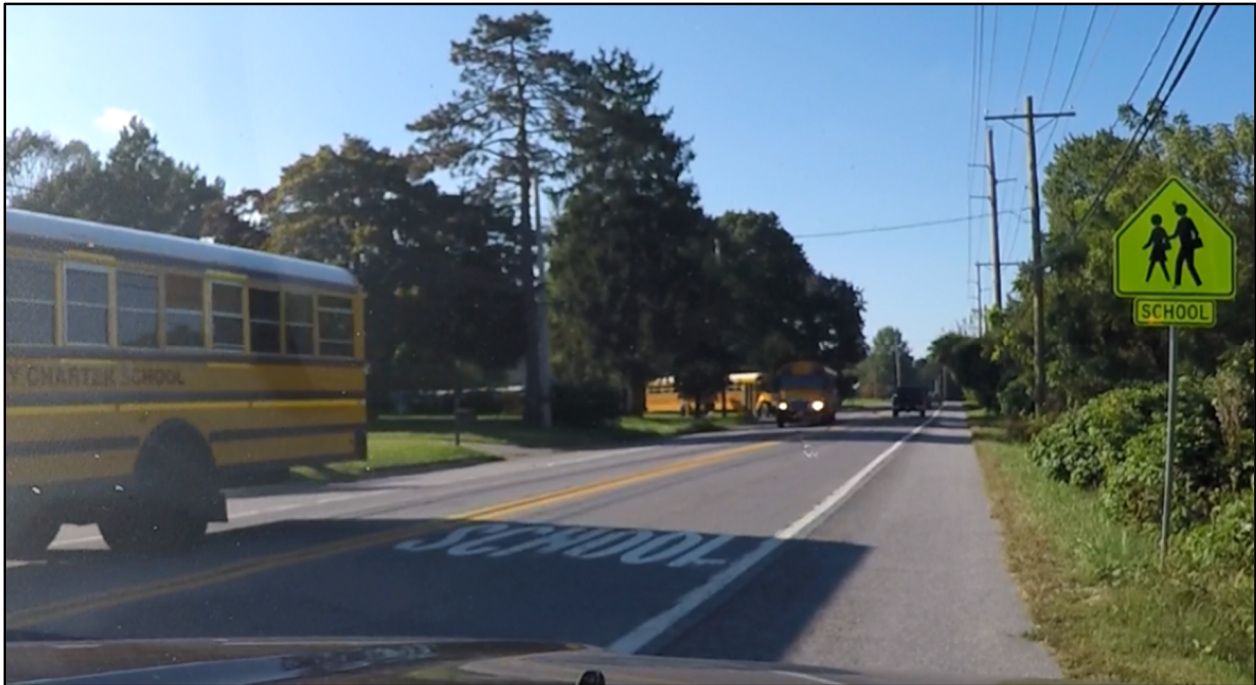
Picture 2: School Buses Turning Right from the School Bus-Only Access to Southbound SR 41

- All of the school buses exiting the school via the School Bus Only Access made right-turns onto southbound SR 41 (see Picture 2).

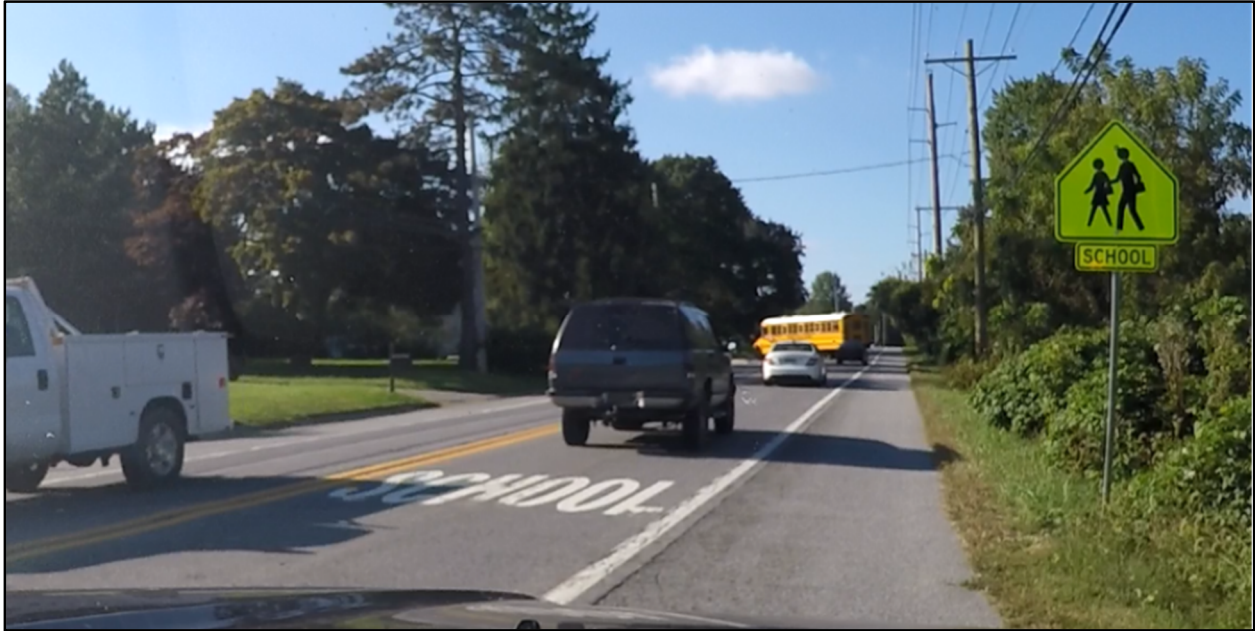
Picture 3: School Buses Making Wide Left-turns from Northbound SR 41, Obstructing Other Northbound Vehicles

- Many school buses were observed making a left-turn into the school from northbound SR 41 via the School Bus-Only Access. School buses were frequently observed swinging wide to the right (e.g., encroaching onto the shoulder) before making the left-turn due to the tight turning radius (see Picture3). This maneuver frequently obstructed other northbound vehicles until the school bus completed the turn.
