# Southern New Castle County / Townsend Monitoring

### Overview

The 2019 Southern New Castle County (SNCC) Master Plan included "Objective 3.2, Strategy 3: Monitoring traffic within the Town of Townsend".

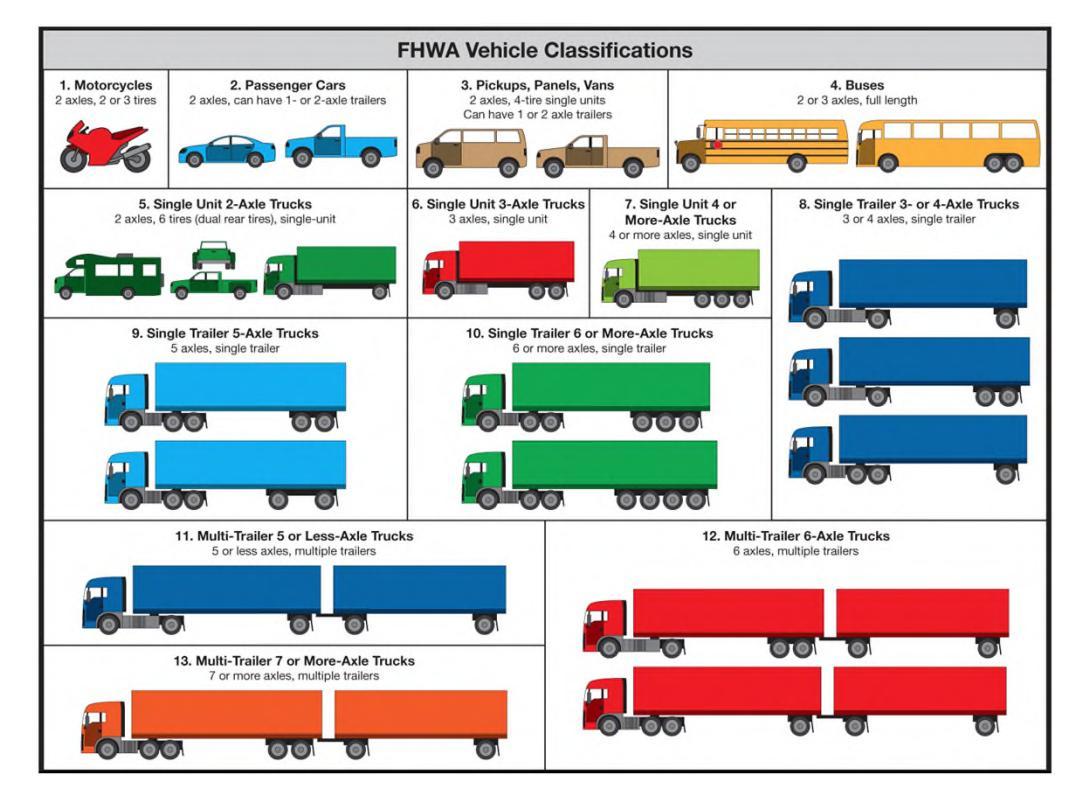
- Evaluated overall Average Daily Traffic (ADT)
- Evaluated truck percentages using vehicle classification data

Bin #	Length	Approximate FHWA Classes	
1	0-25ft	1 - 3	
2	25-49ft	4 - 7	Trucks
3	49-256ft	8 - 13

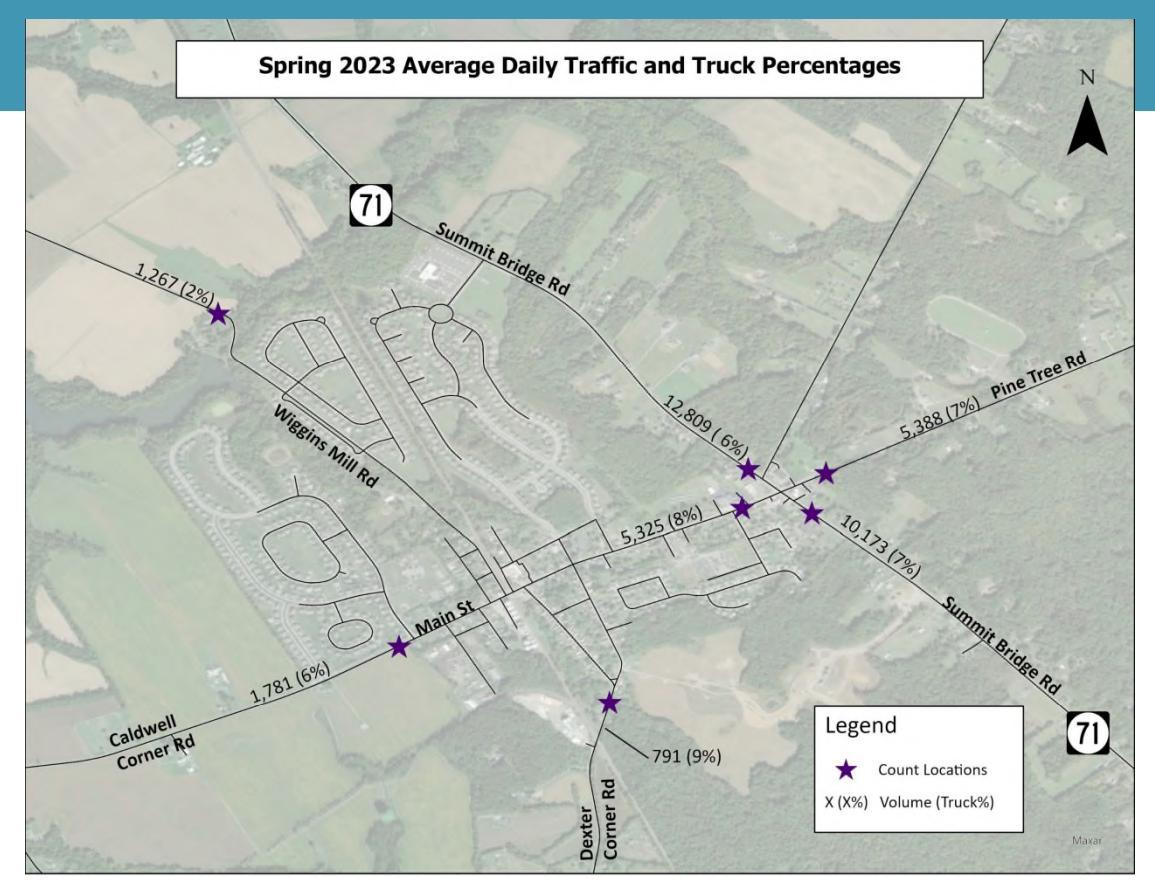
- Area ADTs do not exceed 13,000
  - ADTs are highest on SR 71 north of Money Rd
- Truck percentages do not exceed 10%
  - Truck percentages are highest on Dexter Corner Rd (9%)
  - Truck percentages are lower than 2021
- Area ADTs have decreased an average of 4% from 2021 to 2023

Volumes shown include both directions of the roadway

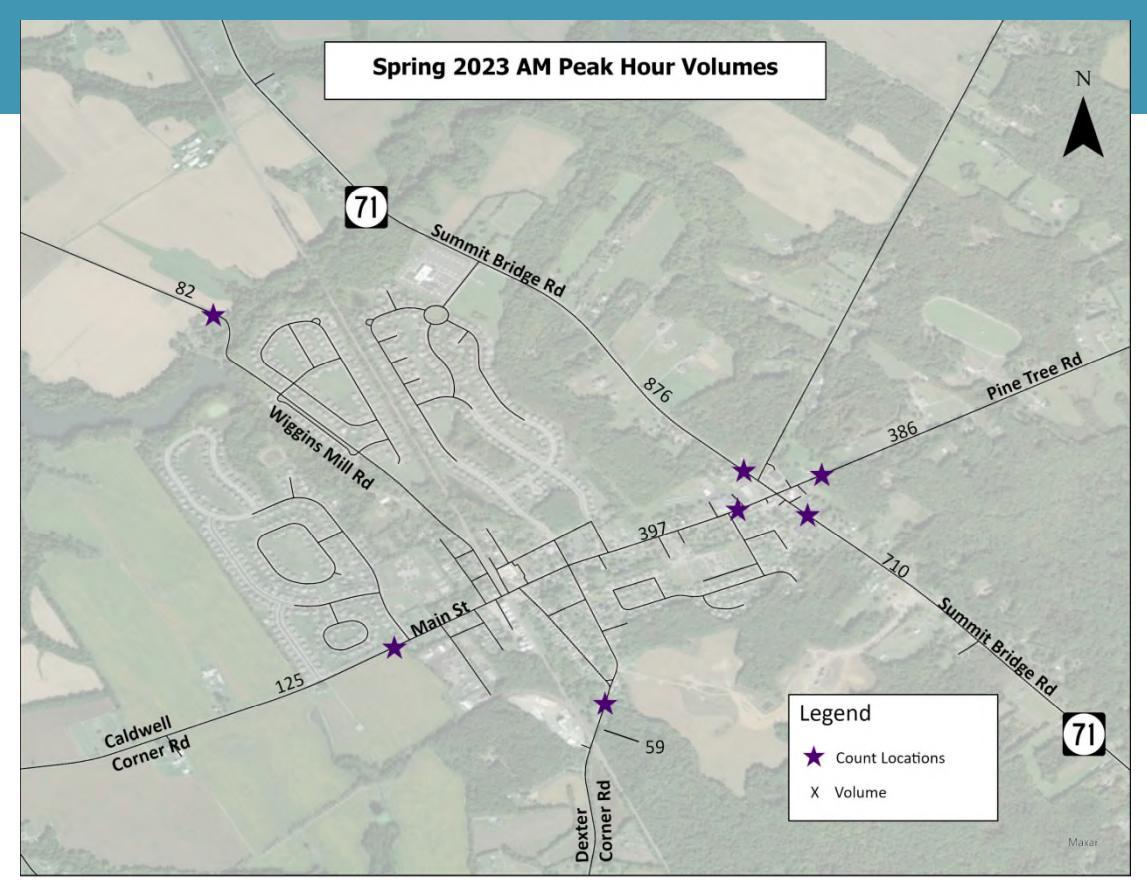
- AM peak hour volumes do not exceed 900 vehicles
  - Peak hour volumes are highest on SR 71 north of Main St/Pine Tree Rd
  - AM peak hour volumes overall are lower than PM peak hour volumes
- 2023 AM peak hour volumes are on average 7% less than 2021 volumes

Volumes shown include both directions of the roadway

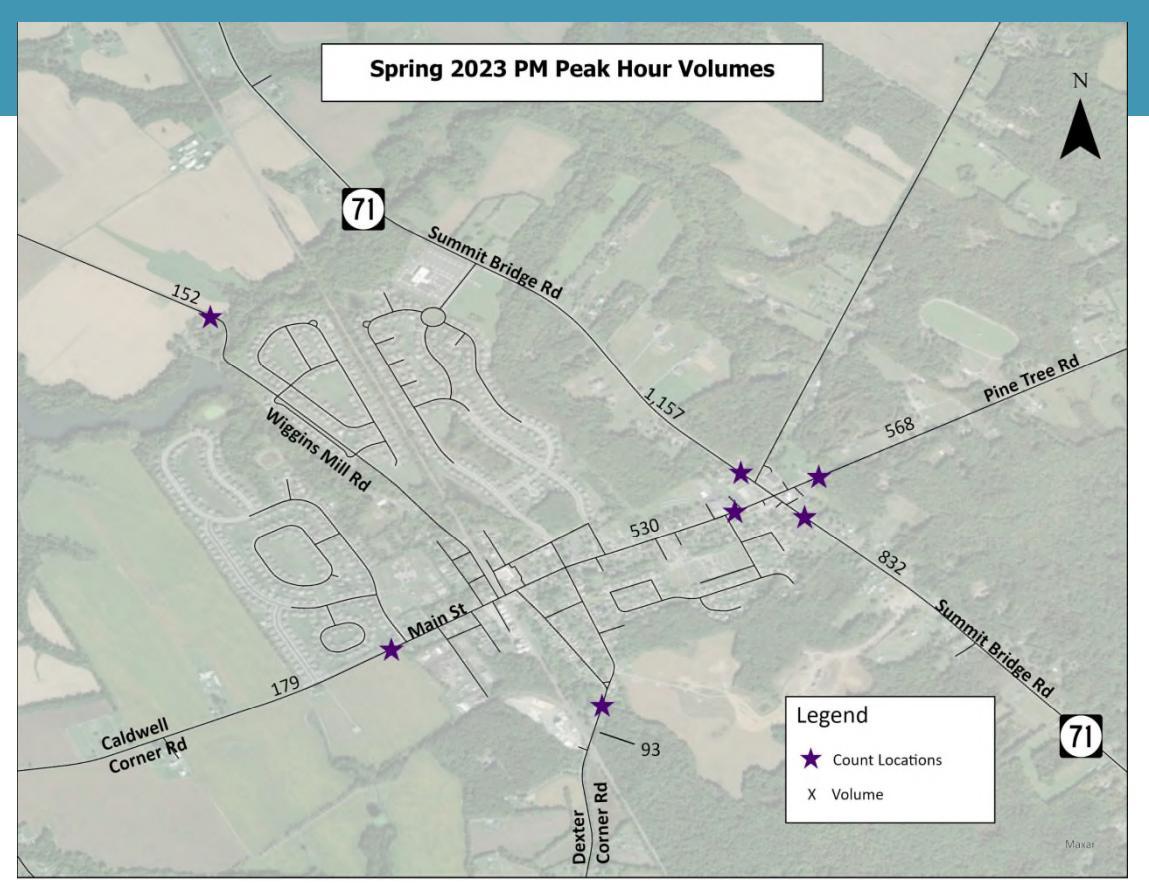
- PM peak hour volumes do not exceed 1,200
  - Peak hour volumes are highest on SR 71 north of Main St/Pine Tree Rd
  - PM peak hour volumes are overall higher than AM peak hour volumes
- 2023 PM peak hour volumes are on average 3% greater than 2021 volumes

Volumes shown include both directions of the roadway

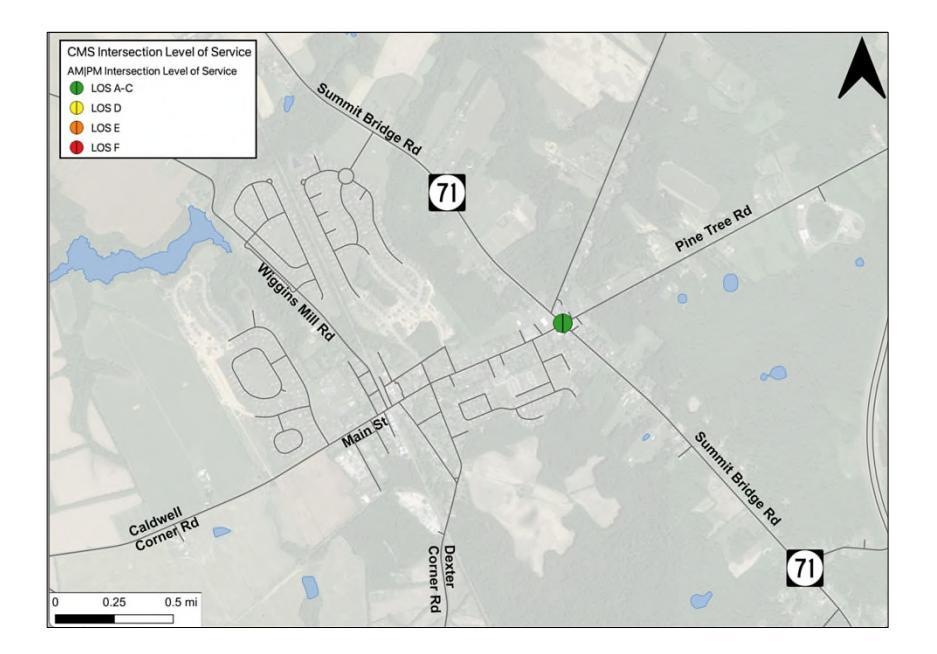
#### At the intersection of SR 71 and Pine Tree Rd:

• LOS A in the AM and PM peak (based on a 2022 count)

- LOS was derived from critical movement summation (CMS) analysis
- This LOS is volume-based, indicating how well the given lane configuration and signal phasing can process traffic demand
- LOS is graded on a scale of A-F

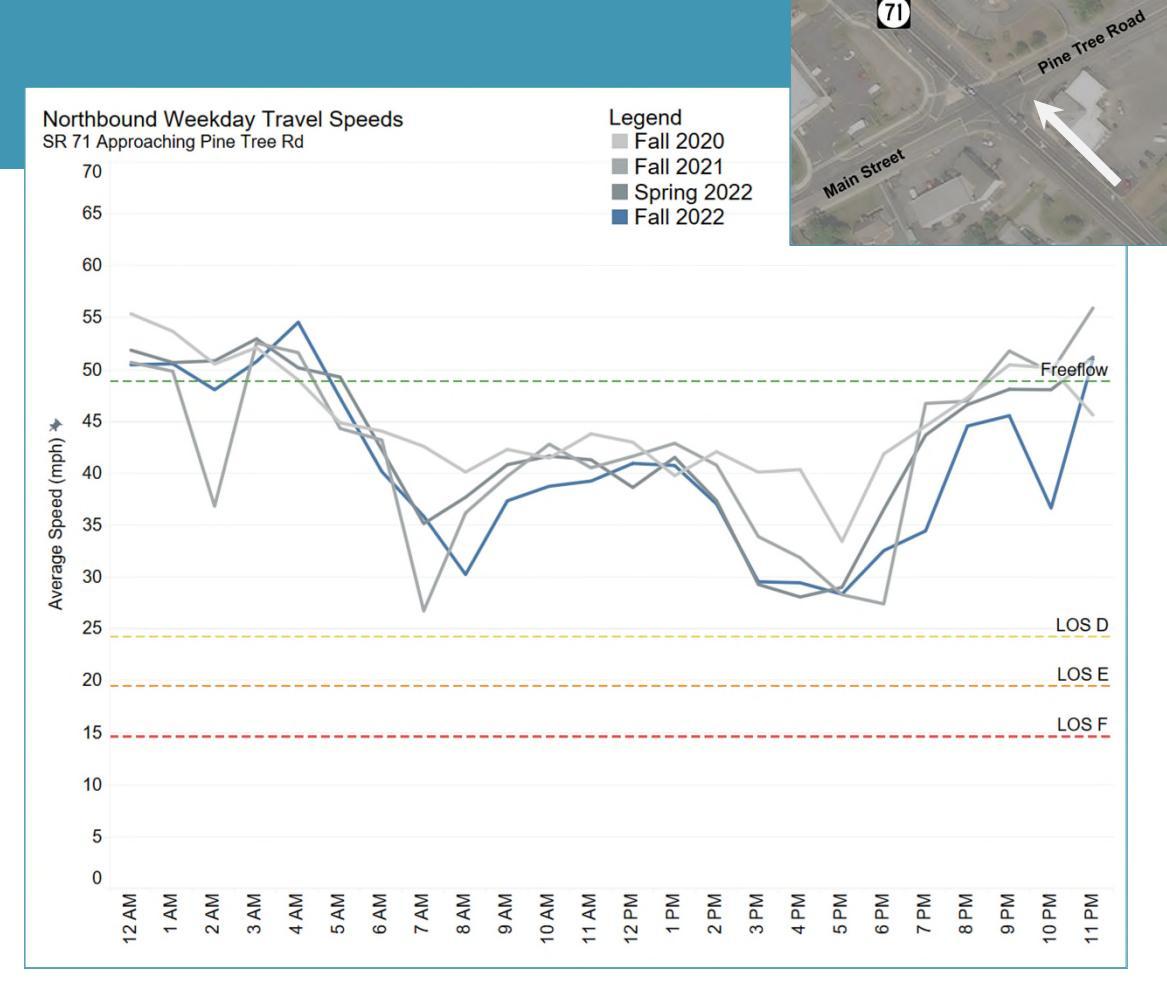
- Northbound travel speeds on SR 71 ٠ approaching Pine Tree Rd have been consistent 2020-2022
- Speeds drop during the AM and PM • peak periods, but do not reach LOS D

LOS thresholds developed using Highway Capacity Manual 6<sup>th</sup> Edition Methodology

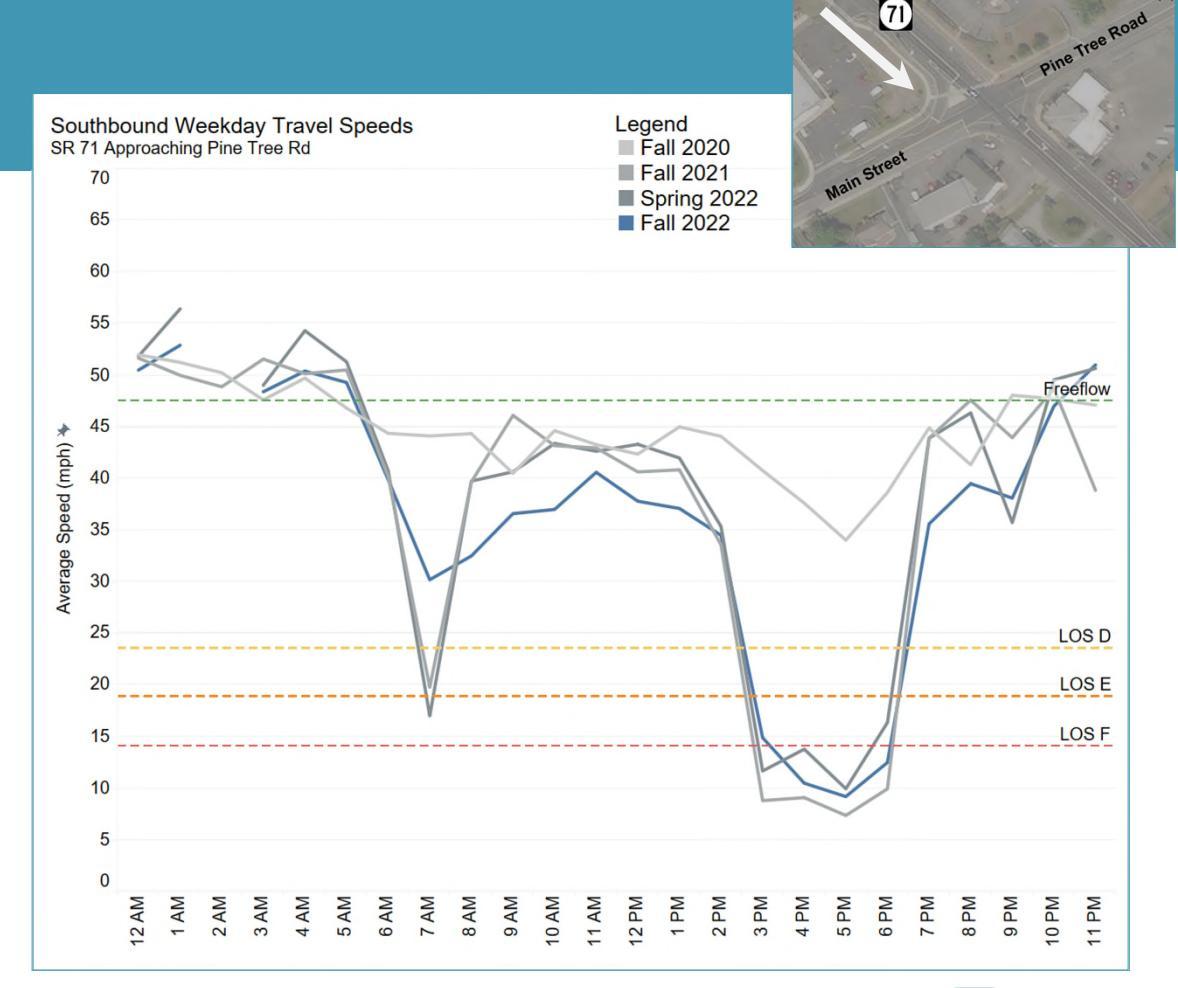
- Southbound travel speeds on SR 71 ٠ approaching Pine Tree Rd have been consistent 2021-2022
  - Travel speeds in 2020 were higher, likely ٠ due to fewer drivers on the road during COVID stay-at-home orders
- Speeds decrease sharply at 7 AM, ٠ though do not reach LOS D
  - In the AM Peak, Fall 2022 speeds were higher than Spring 2022 and Fall 2021
- Travel speeds in the PM peak, from ٠ 3 PM-7 PM, drop to 10-15 MPH, resulting in LOS F

LOS thresholds developed using Highway Capacity Manual 6<sup>th</sup> Edition Methodology

- 1. Southbound travel times during peak periods are congested.
- 2. Traffic volumes do not appear to be a concern.
- 3. Crashes increased from 2018 to 2021 and then reduced almost in half in 2022.

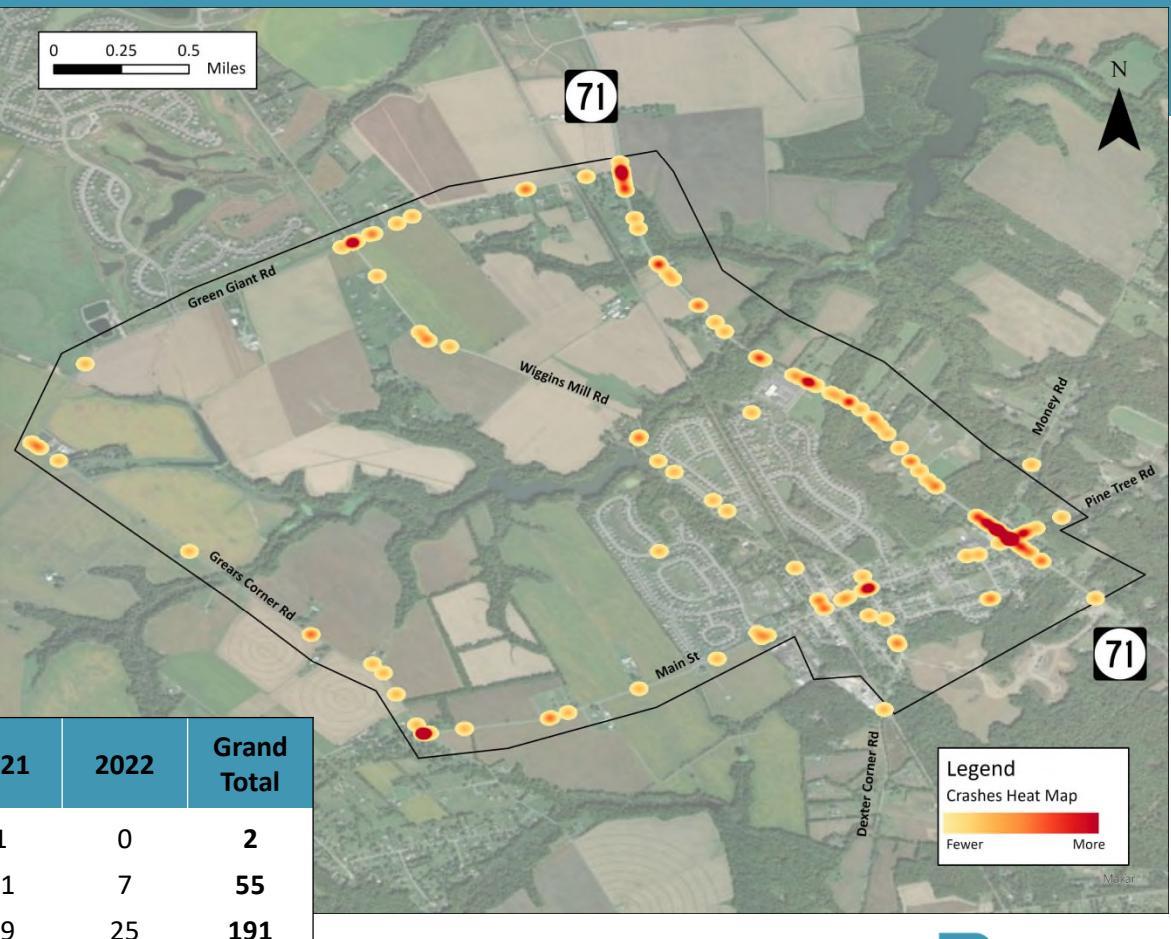
- A heatmap of 2018-2022 crash data reveals most crashes occur at intersections:
  - SR 71 at Pine Tree Rd
  - Main St at Grears Corner Rd
  - SR 71 at Green Giant Rd
  - Main St at Dexter Corner Rd
  - Wiggins Mill Rd at Green Giant Rd

· · ·	
Crash Classification	2018	2019	2020	2021	2022	Grand Total
Fatality Crash	1	0	0	1	0	2
Personal Injury Crash	10	10	17	11	7	55
Property Damage Only	42	38	37	49	25	191
Grand Total	53	48	54	61	32	248

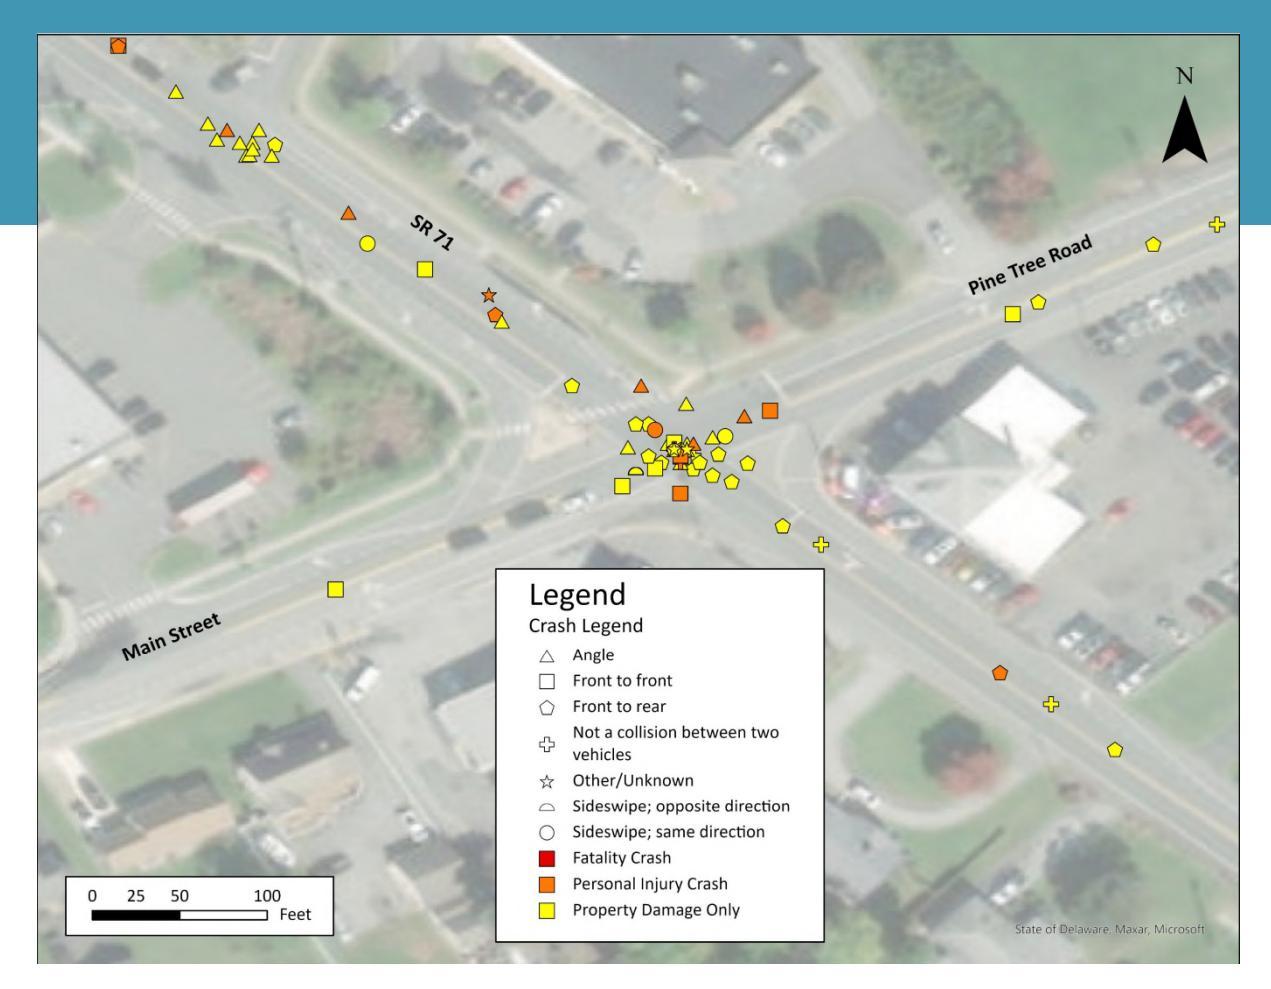
- Roughly half of the crashes at SR 71 at Pine Tree Rd were angled crashes
  - There is a noticeable cluster of angled crashes at the Dollar General driveway just north of the intersection
- 30% of the crashes are front-torear impacts

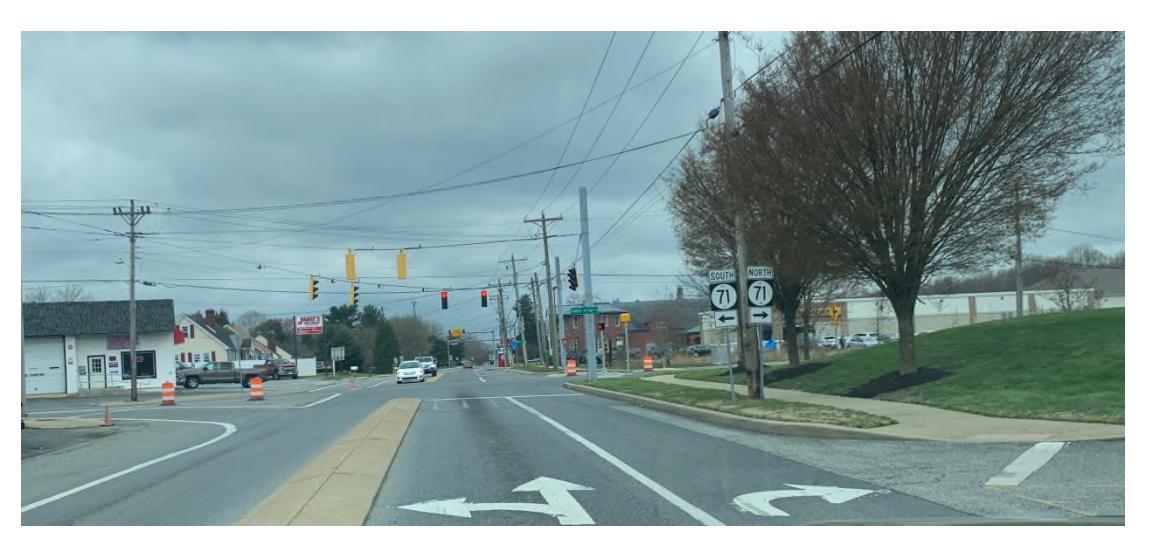
Looking west on Pine Tree Road at the intersection with SR 71.
