SR 48 AT OLD WILMINGTON ROAD TRAFFIC SIGNAL WARRANT EVALUATION JANUARY 30, 2019

The following study presents the signal warrant analysis at SR 48 (Lancaster Pike) and Old Wilmington Road.

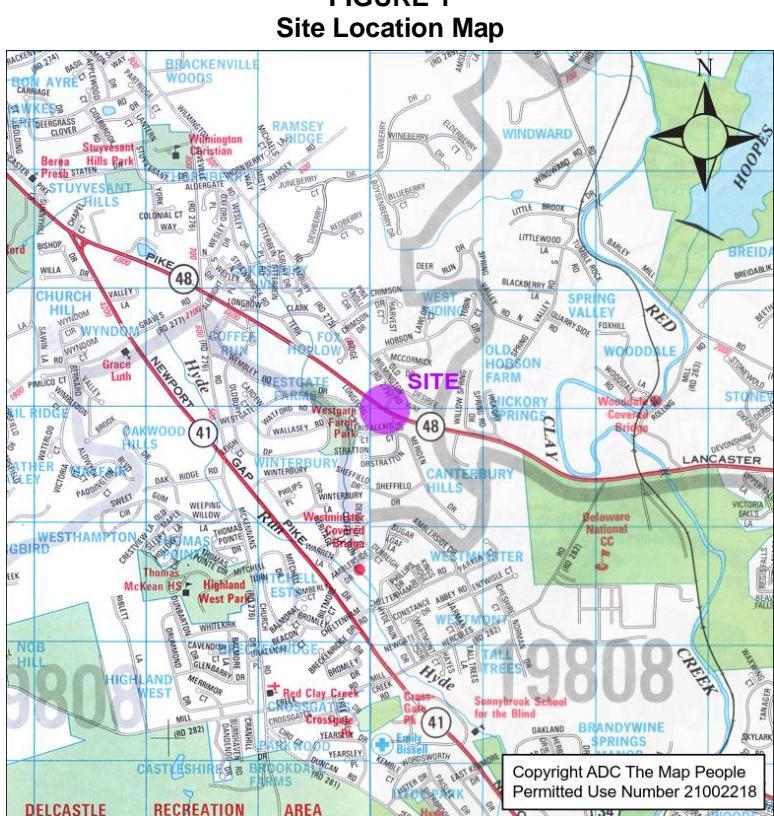
FIGURE 1

The intersection of SR 48 and Old Wilmington Road is located approximately 2.5 miles northwest of the City of Wilmington (see Figure 1). The intersection is located between the signalized SR 48 intersections with Loveville Road to the west and Hercules Road to the east. The eastbound approach contains a through lane and a left-turn lane. The westbound approach contains a through lane and a right-turn lane. SR 48 is an undivided roadway; however, there is a striped median in the vicinity of Old Wilmington Road. Old Wilmington Road is a two-lane, undivided roadway with a left-turn lane and a right-turn lane on the southbound approach. The speed limit is 50 mph on SR 48 and 40 mph on Old Wilmington Road. Southbound Old Wilmington Road is stop-controlled at SR 48, while SR 48 is free.

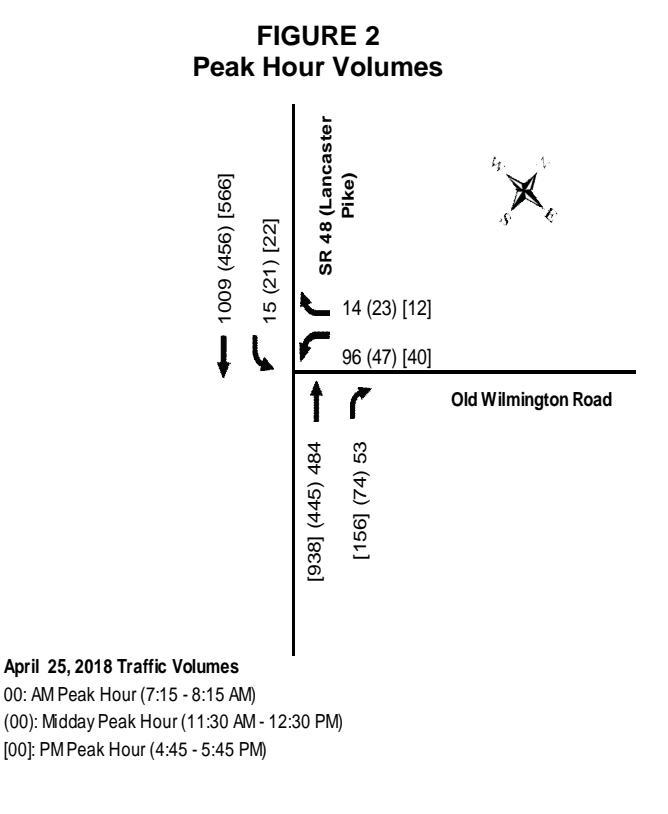
Turning movement counts were conducted on Wednesday, April 25, 2018 from 6 AM to 7 PM and the results are depicted in Figure 2.

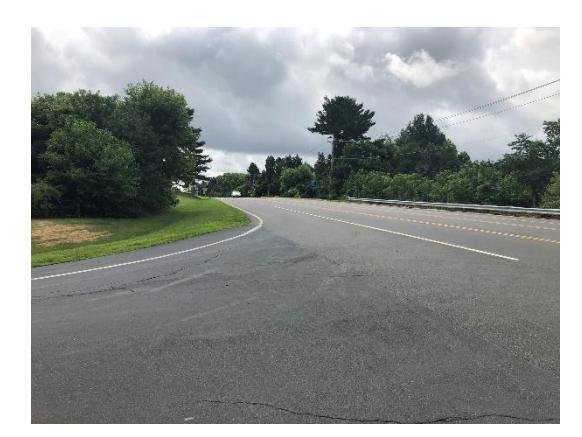
Photo 1: Southbound Old Wilmington Rd corner sight distance looking left onto SR 48 (from stop line)

As shown in Table 1, the southbound Old Wilmington Road corner sight distances looking left and right at SR 48 do not meet AASHTO criteria when vehicles are positioned at the stop line (view is obstructed by trees to the right and a vertical curve to the right; see Photos 1-2). Southbound Old Wilmington Road corner sight distances looking left meet AASHTO criteria when vehicles move beyond the stop line, but the corner sight distance is still not met looking right (see Photos 3-4). The stopping sight distances for eastbound SR 48 exceed AASHTO criteria; however, they are not met on westbound SR 48 due to the vertical curve.

Corner Sight Distance									
Approach	Looking Left (688 ft required)				Looking Right (769 ft required)				
Approach	From stop line	Criteria Met?	Beyond stop line	Criteria Met?	From stop line	Criteria Met?	Beyond stop line	Criteria Met?	
Southbound Old Wilmington Rd	508 ft	Νο	706 ft	Yes	725 ft	No	730 ft	No	
	Stopping Sight Distances								
Appro		Measured		Criteria		Criteria Met?			
Westbound SR 48			345 ft		456 ft		No		
Eastbound		525 ft		401 ft		Yes

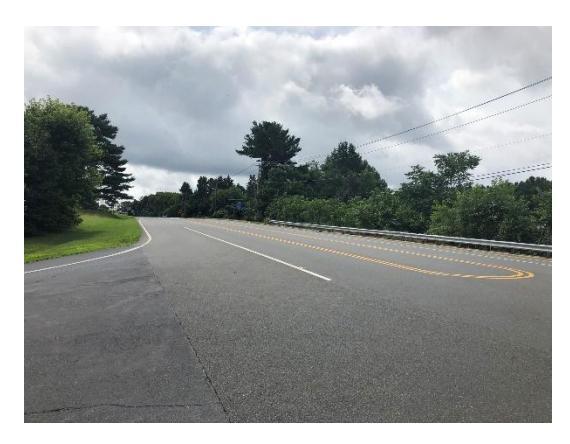
Photo 3: Southbound Old Wilmington Rd corner sight distance looking left onto SR 48 (beyond stop line)

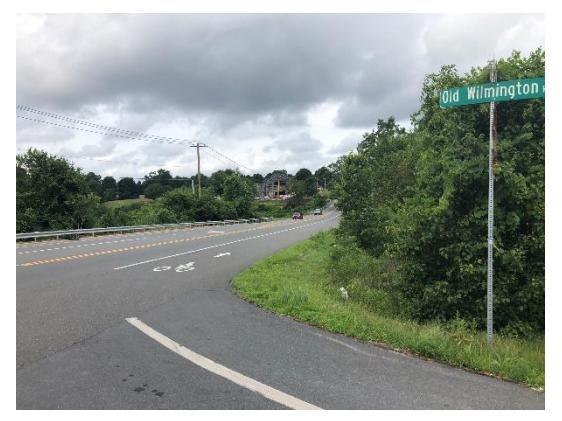
Photo 2: Southbound Old Wilmington Rd corner sight distance looking right onto SR 48 (from stop line)

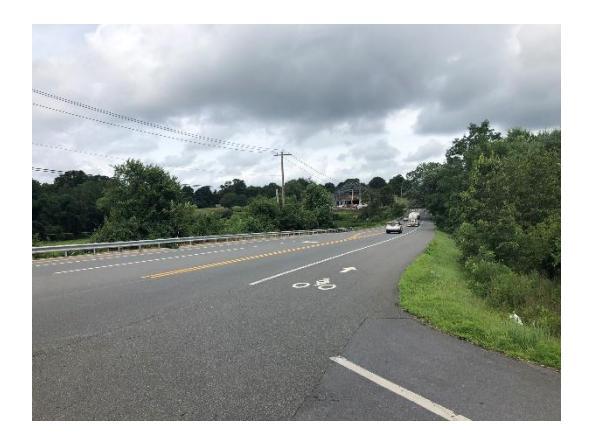
Photo 4: Southbound Old Wilmington Rd corner sight distance looking right onto SR 48 (beyond stop line)

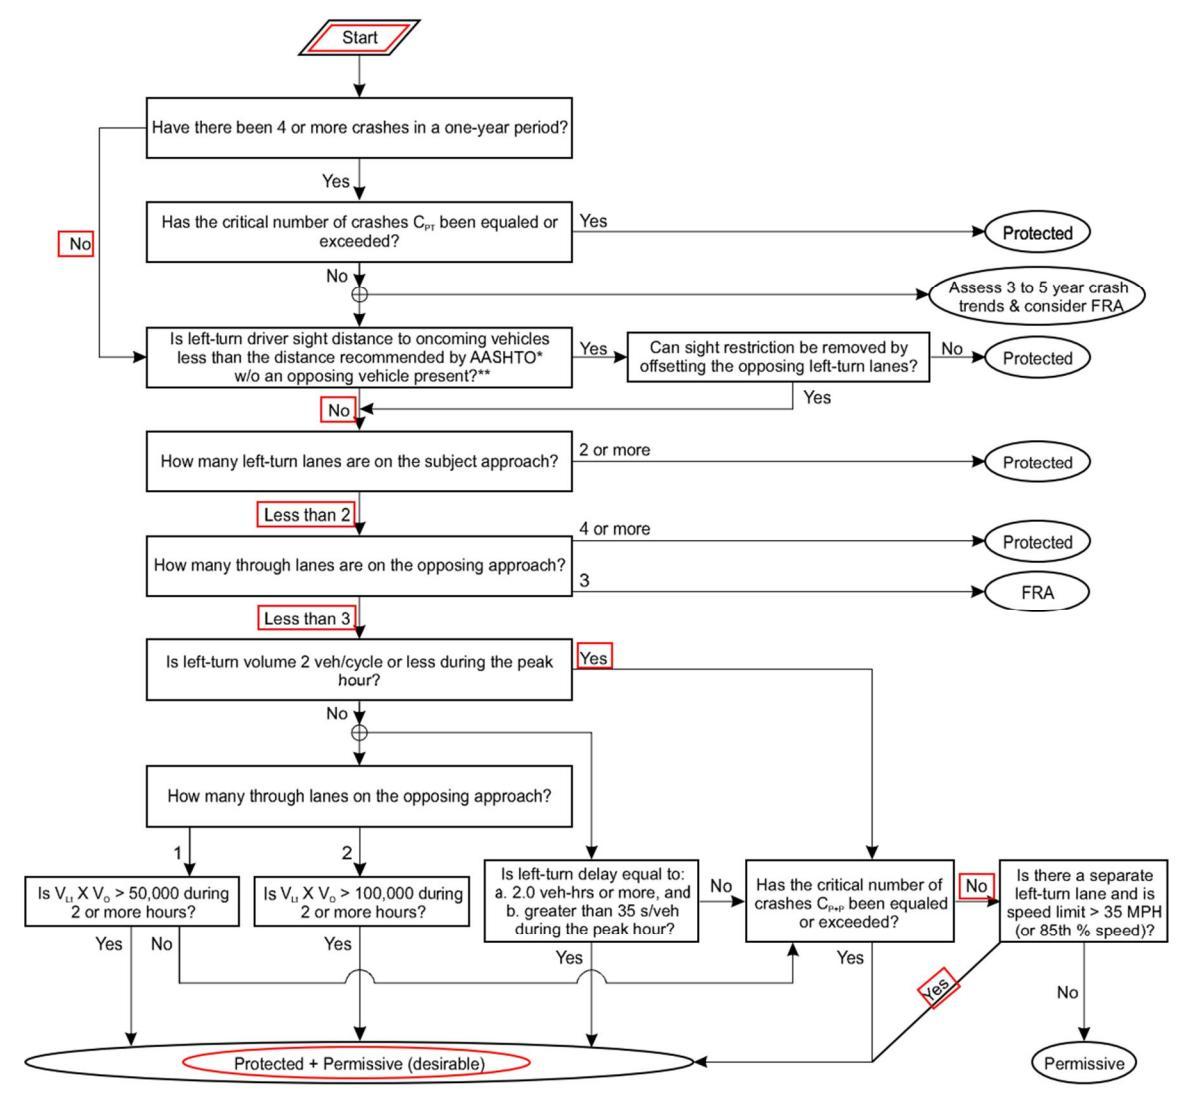
Guidelines for determining left-turn lane signal phasing treatment

*AASHTO, <u>A Policy on Geometric Design of Highways and Streets</u>, 2011 (or current), Chapter 9, 9.5.3 Intersection Control, Case F - Left Turn From the Major Road. Calculated based on Equation 9-1 and Table 9-13, adjusted for number of lanes, as needed. **If left-turn driver sight distance is temporarily obstructed by an opposing left-turning vehicle and consequently temporarily less than AASHTO recommendations, consideration should be given to the obstruction's frequency and the potential for and severity of crashes (e.g., consider opposing left turn phasing, opposing through speeds and volumes).

Variables:

$\overline{V_u}$ = left-turn volume on the subject approach, veh/h

V_o = through plus right-turn volume on the appoach opposing the subject left-turn movement, veh/h

Source:	Number of	Period During	Critical Left-Turn-Related Crash Count		
Adapted from FHWA's	Left-turn	Which Crashes	When Considering	When Considering	
Signal Timing Manual	Movements on	are Considered	Protected-only, C _{pt}	Prot.+Perm., Cp+p	
	Subject Road	(years)	(crashes/period)	(crashes/period)	
	One	1	6	4	
	One	2	11	6	
	One	3	14	7	
	Both	1	11	6	
	Both	2	18	9	
	Both	3	26	13

Additional analyses were conducted to compare the delay and queue lengths for the peak hours for the existing stop-controlled intersection and if a signal were installed at the intersection. *Synchro* and *SimTraffic* models were utilized to estimate the average intersection delay and the Old Wilmington Road southbound left-turn delay and queue length, as shown in Table 4 and Table 5. The proposed signal was modeled with a 150-second AM and 120-second PM cycle length to maintain coordination along the SR 48 corridor. The proposed signal was modeled with eastbound left-turn permissive phasing, and then with eastbound left-turn protective-permissive phasing based on the results from left-turn lane signal phasing flow chart, as seen in the Appendix.
